**Docket No. 217 – Development and Management Plan Inspection**

Northeast Utilities Service Company Certificate of Environmental Compatibility and Public Need for the construction of a 345-kV electric transmission line and reconstruction of an existing 115-kV electric transmission line between Connecticut Light and Power Company's Plumtree Substation in Bethel, through the towns of Redding, Weston, and Wilton, and to the Norwalk Substation in Norwalk, Connecticut.

**Date:** March 15, 2006

**Location:** Overhead Line (Composite 345kV and 115kV Gallows Hill to Archers Lane) and (345kV H-Frame Hoyts Hill to Gallows Hill)

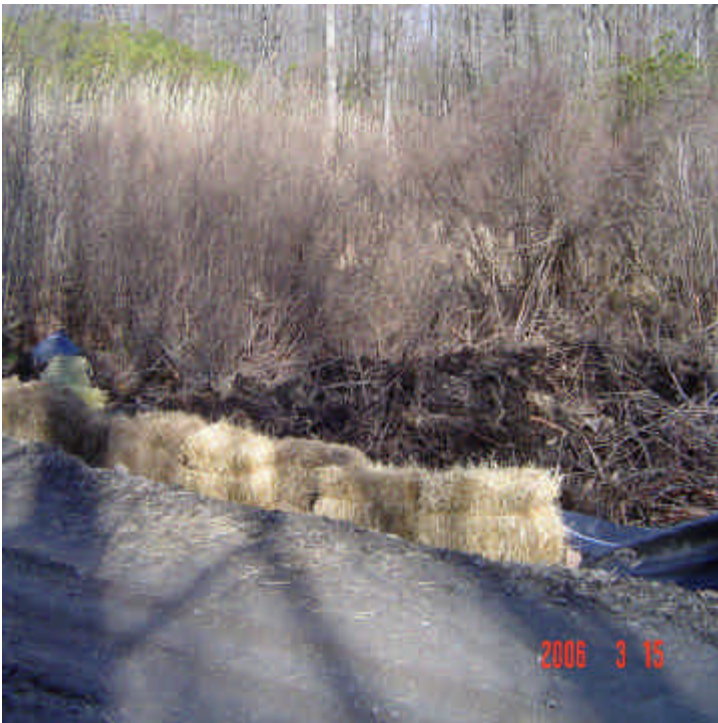
Areas of Inspection	Observation	Recommended Action	Corrective Action
<b>345kV H-Frame</b>	- A skidder had slipped off the road into the 3 <sup>rd</sup> wetland area 2/16/06. Haybales had been placed but ruts in the wetland remain. 3/9-3/15/06.	- The damage should be repaired at the 3 <sup>rd</sup> wetland. See erosion control section for more details. 2/16- 3/15/06.	-Haybales were placed at the 3 <sup>rd</sup> wetland area but ruts remain. See erosion control section for more details.

(Composite Section-Archers Lane): Photo on the left shows a view of the 3<sup>rd</sup> crossing at Archers Lane where the skidder slipped off the road. Haybales have been placed but ruts remain in the wetland. Photo on the right shows a general view of the third crossing where trees are marked for clearing. 3/15/06

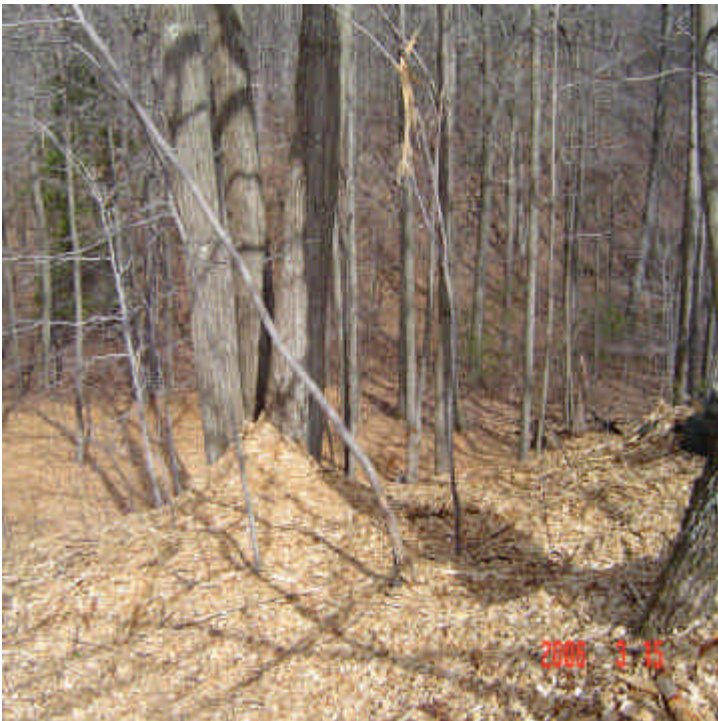
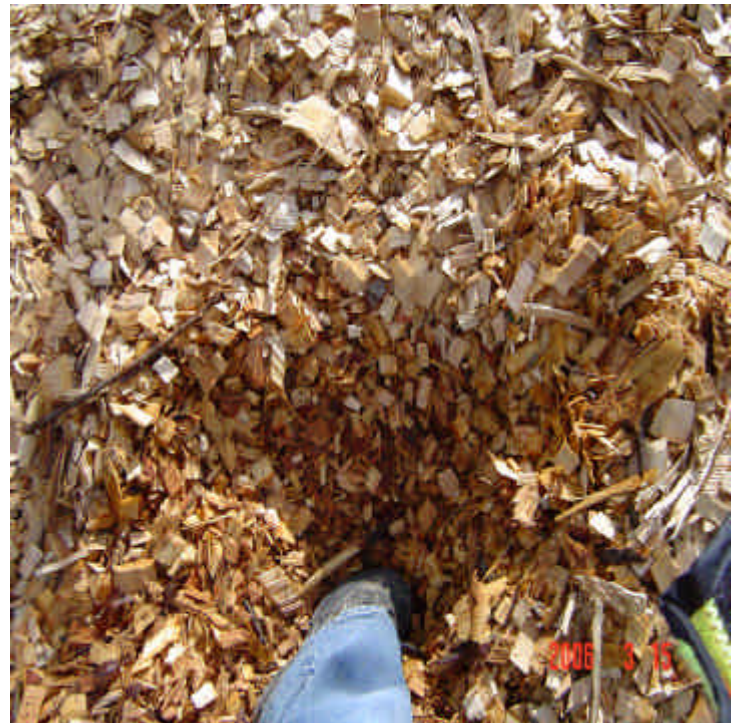
- A significant amount of chips were blown off the ROW into the upland and also along the wetland edge at the 3 <sup>rd</sup> structure off Gallows Hill. This could smother plants and reduce habitat. 2/22-3/15/06.	- Chips currently off ROW boundaries should be removed carefully to comply with the D&M plan. 2/22-3/15/06. Chips on ROW should be spread to a depth of 3". 3/15/06	- CL&P is looking into this.
	-This was also noted several structures past Archers Lane. 3/15/06		
	-Clearing continues along the ROW at Archers Lane and a number of trees are marked for removal in a wetland which also serves as amphibian breeding habitat. 3/15/06.	- To avoid wetland damage, the trees will be sheared from the access road and felled out of the water. 3/15/06	- CL&P proposed the work under these specs.
<b>345kV H-Frame</b>	-Significant clearing continues along the Chestnut Ridge Rd, Costa Lane, and John Todd Way sections. Wood chips were placed along portions of the	- Chips spread on the ROW should be spread to a depth not more than 3" by the time the growing season is about to begin. 3/15/06.	-N/A at this time

Both photos show the excess wood chips that have been blown off the cleared ROW into an undisturbed upland area. Photo on the right demonstrates that the wood chips were spread at a depth greater than three inches. CL&P is looking into a solution here. 3/15/06.

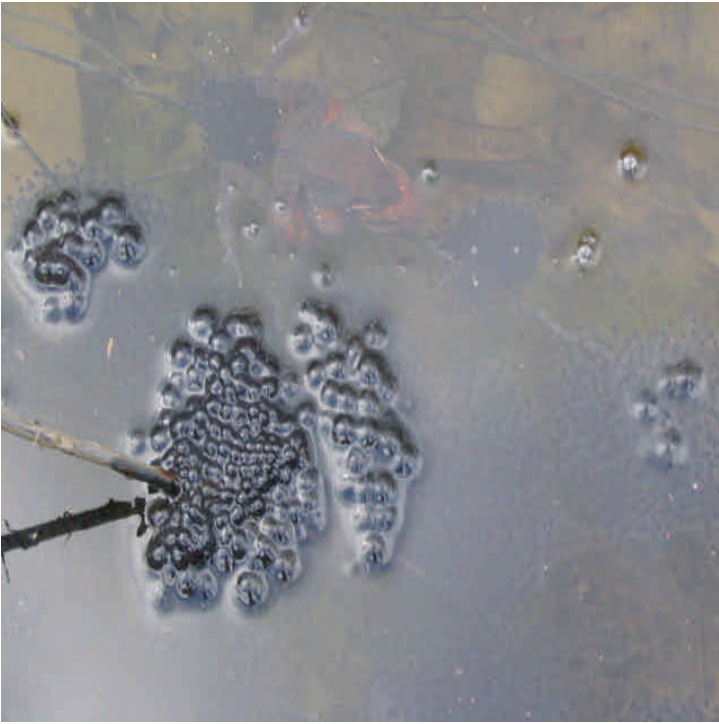
**(Composite Section-Gallows Hill):** Photo on the left shows a view of wood frog egg masses found throughout the wetland located near the 2<sup>nd</sup> structure. Photo on the right shows the portion of the wetland where erosion controls should be extended to prevent sedimentation to this breeding habitat. 3/15/06.

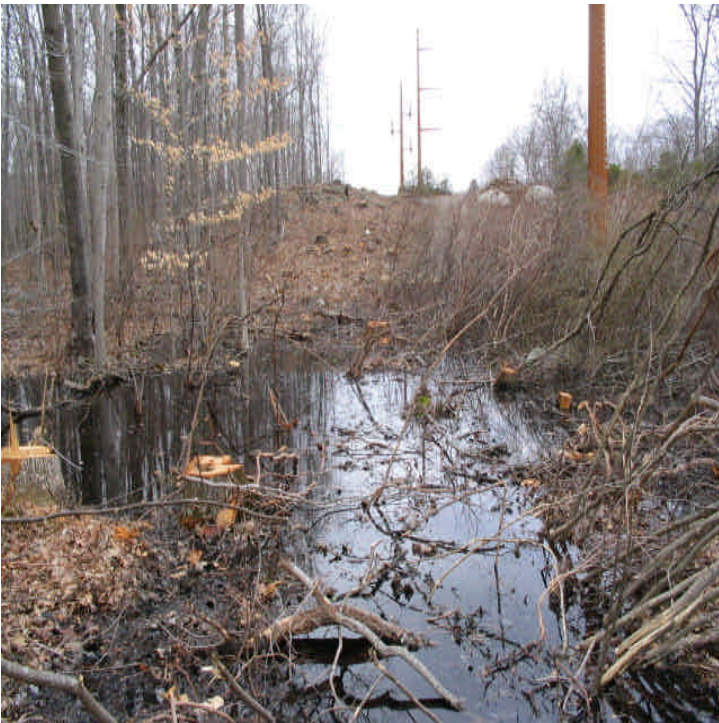
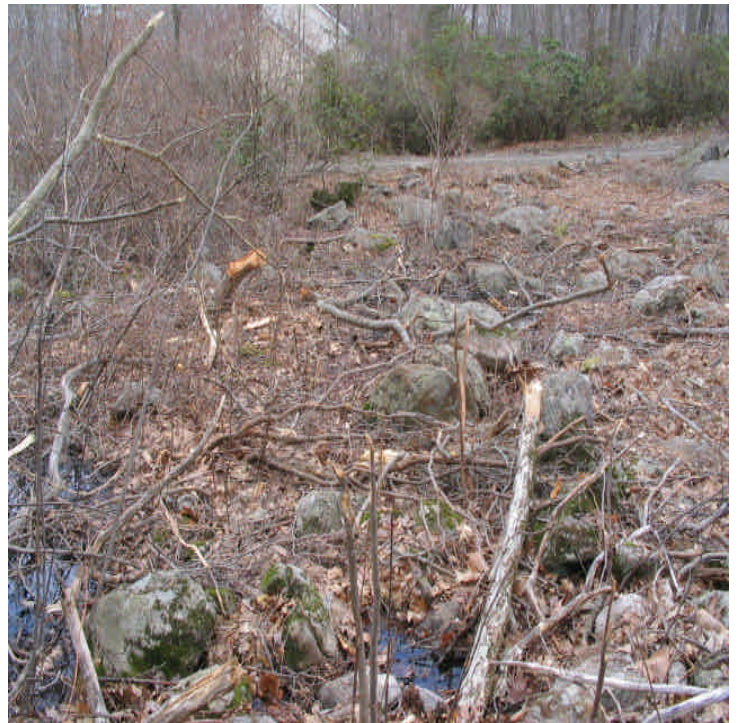
Areas of Inspection	Observation	Recommended Action	Corrective Action
	<p>roads. 2/16-3/15/06.</p> <p>-Large branches and brush were noted in wetlands and stream areas in a number of locations. 2/9-3/15/06.</p> <p>-In all sections make efforts to retain shrubs, especially in wetland areas. Efforts have been noted in some areas but could have improved in others. -3/15/06.</p>	<p>- Carefully remove any larger branches or brush strewn in streams and wetlands which are not currently being used for amphibian breeding habitat 3/15/06.</p> <p>Keep clearing to what is necessary. The D&amp;M plan states low growing shrubs can remain. 12/22-3/15/06.</p>	
Dewatering	<p>- Dewatering had occurred at structure #6. Water appeared to be running clear beyond the controls installed. No additional sediment was noticed beyond the controls in this area. 3/9-3/15/06.</p>	<p>- Release water to the ground only in well vegetated areas if it will not reach any resource areas. (Make sure to check downgradient for these areas) Otherwise use a filter bag or adequate containment. 3/9-3/15/06.</p>	<p>-Silt fence and hay bales were used properly for this dewatering.</p>

**Photo on the left shows cleared portions within this same wetland. Both photos show brush deposited within and along the edges of this wetland. 3/15/06.**

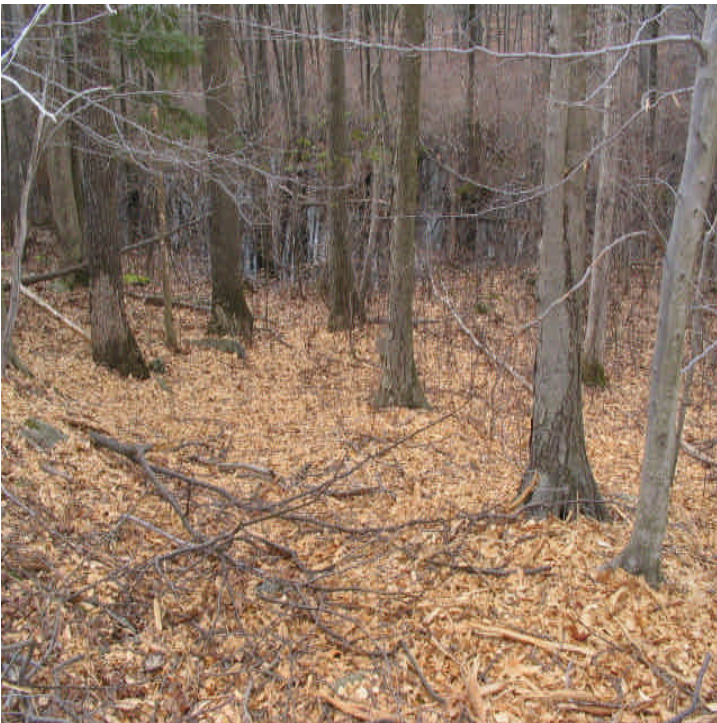
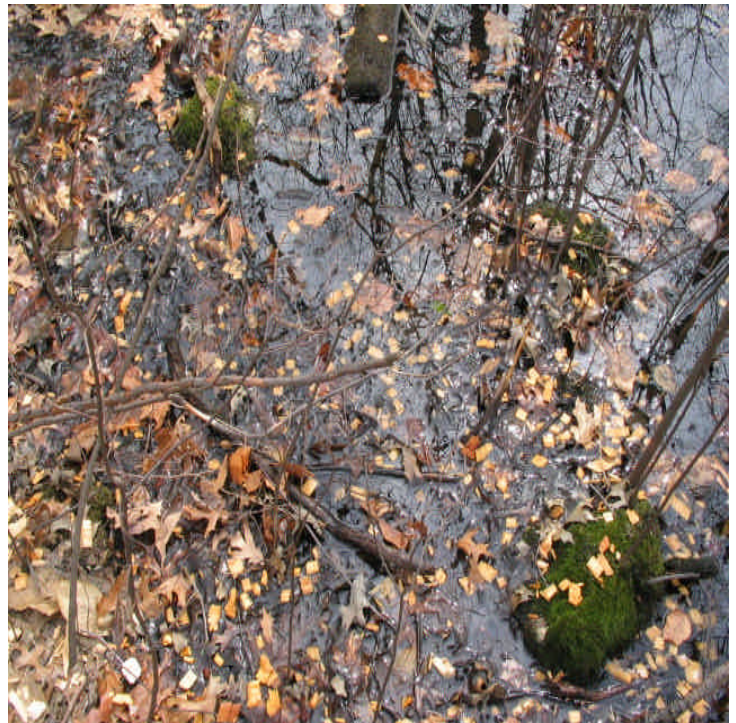
**Photo on the left shows a view of the wood chips that have been blown off the cleared ROW and along the edge of the wetland near structure #3. Photo on the right shows one of the areas where blown chips have reached the wetland. 3/15/06.**

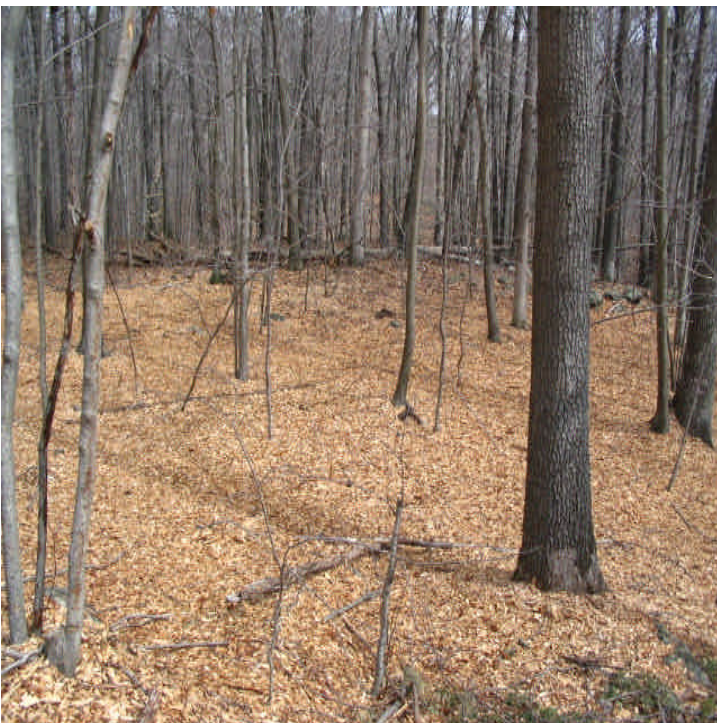
**Photo on the left shows a view of the wood chips blown off the cleared ROW into the undisturbed upland area located on the opposite side of the ROW from the wetland shown above. Photo on the right shows a small fuel stain located between structures #2 and #3. 3/15/06.**

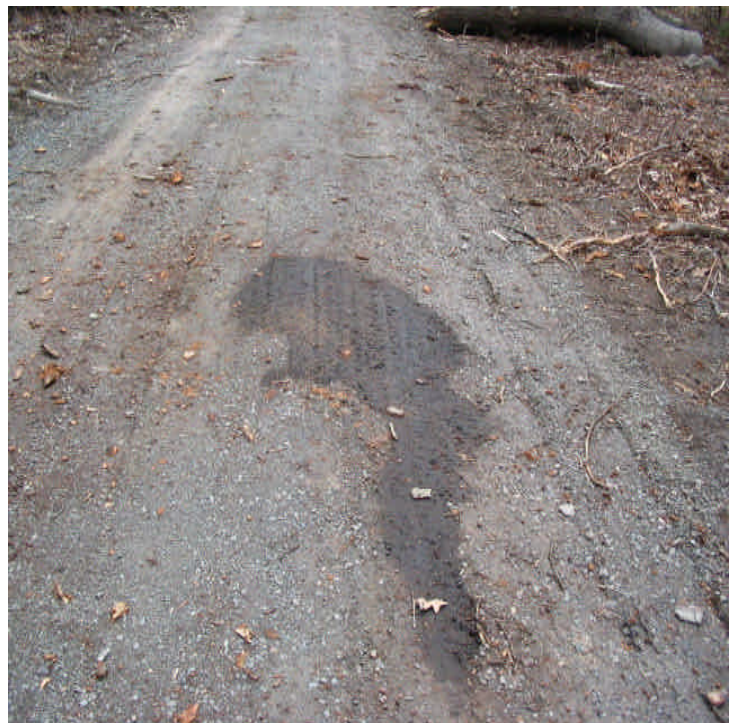
Blasting	<p>-No blasting has been necessary at this time on the ROW. 3/15/06.</p>	<p>-None at this time. 3/15/06.</p>	<p>-N/A</p>
Spills and Material Storage	<p>-None of the parked or active equipment was leaking at the time of inspection, but there was an old spill noted on the access road between the 2<sup>nd</sup> and 3<sup>rd</sup> structure in from Gallows Hill. 3/15/06</p> <p>- Poles were also noted stored in the wetland area between poles 5-6. Avoid creating ruts when removing these for installation and avoid future storage in wet areas 3/15/06</p>	<p>-Clean the affected area and investigate the source of the fuel leak. 3/15/06.</p> <p>- Continue to keep all vehicles maintained well (i.e. no apparent fluid leaks) if they will be used or stored on site</p> <p>- Keep adequately size fuel kits for worst case scenarios.</p> <p>- Report spills immediately, even if they are being controlled.</p> <p>- Take care not to get carried away and to be vigilant when refueling. Avoid refueling in the areas near the wetlands. Use proper storage for all materials.</p>

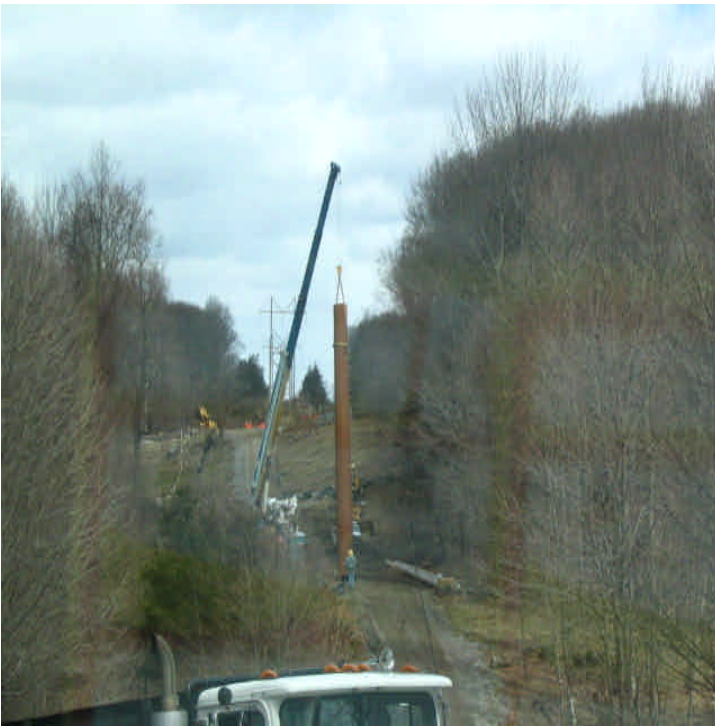
**(345kV H-Frame):** Photo on the left shows structure #8 being installed along the Chestnut Ridge section. Photo on the right shows the area used for dewatering at structure #6. No sediment has migrated beyond the erosion controls. 3/15/06

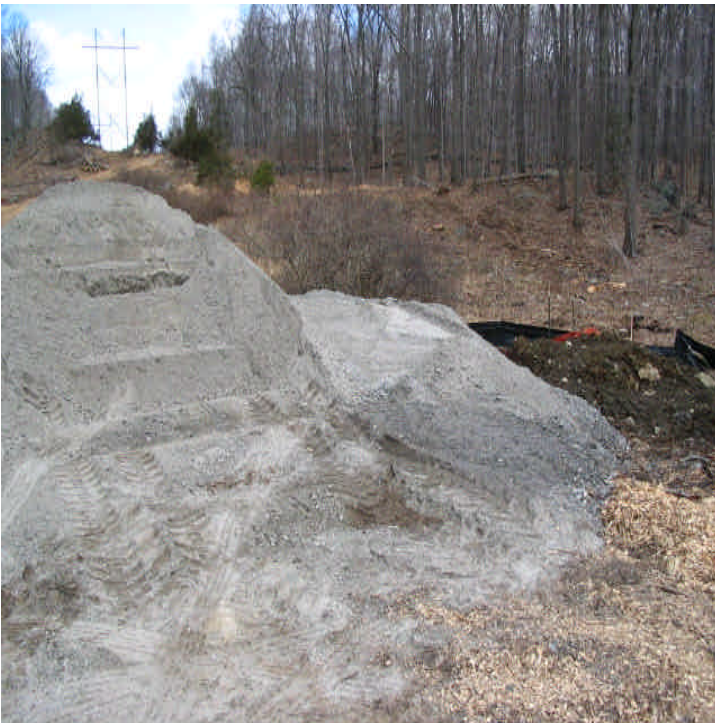
- A portion of the sediment near structure #6 has been removed. Continue to work on the remainder as the pile is in a wetland area. 2/22-3/15/06. An additional temporary stockpile associated with pole excavation has been placed in this area, upgradient of the silt fence. This pile is temporary and will be removed after the structure is installed. 3/15/06.	- Remove the soil here as soon as conditions can support this without further impact. 2/22-3/15/06.  -Monitor the temporary stockpile and install additional erosion controls if necessary. Remove this pile as soon as feasible. 3/15/06.	-N/A until conditions are stable.

Photo on the left shows the temporary stockpile stored near structure #6. This pile should be removed as soon as pole installation is complete. Photo on the right shows the area of access road between poles #5 and 6 which was placed with chips. Poles were accidentally stored in wetland; use caution when removing them for installation. 3/15/06

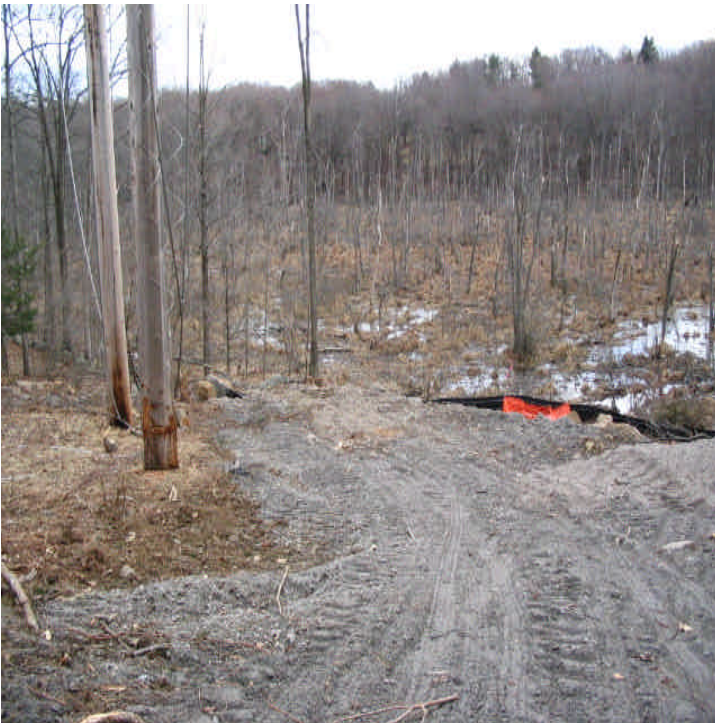
**Photo on the left shows the stone dust access road off John Todd Way approaching structure #24.  
Photo on the right shows a view of the repaired erosion controls adjacent to the wetland here.  
3/15/06**

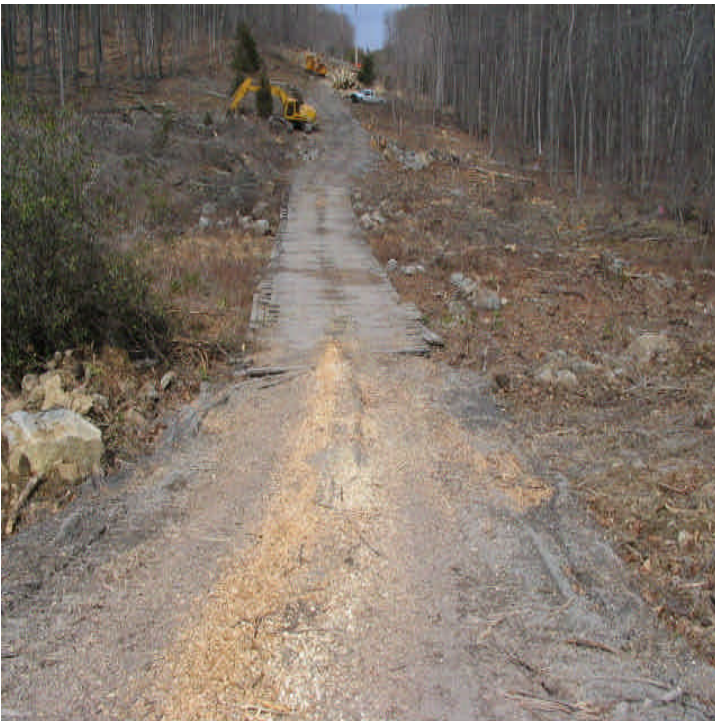
**Photo on the left shows the crossing off Costa Lane near structure #28. Silt fence should be installed at the four corners of this crossing. Photo on the right shows the erosion controls installed around the stockpile and pole excavations at structure #30. 3/15/06**

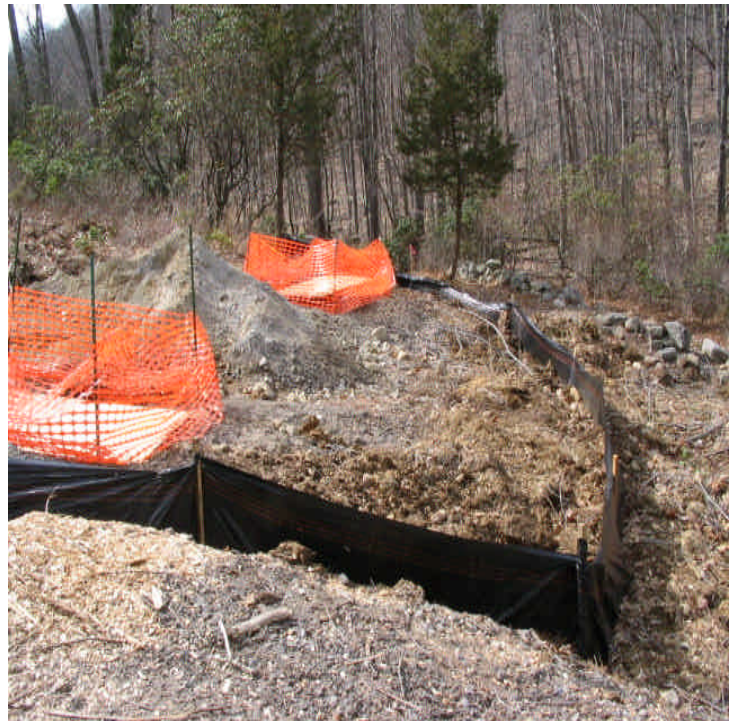
Areas of Inspection	Observation	Recommended Action	Corrective Action
Costa Lane and John Todd Way	<p>this section. 3/15/06</p> <p>-Mats have been installed at the wetland crossing in the vicinity of pole #28. 3/2-3/15/06.</p> <p>-Silt fence has been installed around the stockpile area near structure #30. 3/15/06</p> <p>-Structure #24 off John Todd Way is adjacent to a large wetland system. Silt fence has been installed properly in this area. 3/15/06.</p>	<p>-Continue to monitor the crossing for increasing muddy conditions and install silt fence at the four corners to prevent further sedimentation. 3/2-3/15/06.</p> <p>-Continue to monitor the erosion controls in this area and remove the stockpile when feasible. 3/15/06.</p> <p>- Continue to monitor and maintain the erosion controls in this area due to its proximity to the wetland. 3/9-3/15/06</p>	<p>-N/A</p> <p>-N/A at this time</p>
<p>Inland Wetland and Watercourse encroachment and mitigation</p> <p><b>Composite</b></p>	<p>-The D&amp;M plan approved stone on geotextile fabric at the wetland crossings had worked well, but at three areas near Archers Lane, turbidity issues have been present. Run-off from the road, the drainage pipe, and snow plow issues had led to sedimentation. 1/4-3/15/06.</p> <p>- Direct damage was noted to the wetland at the 3<sup>rd</sup> crossing as a result of equipment slipping. 2/16-3/15/06.</p> <p>- The rocks at the 1<sup>st</sup> crossing remain clogged with sediment and noticeable deposits were in the wetland. 1/4-3/15/06.</p> <p>- Use caution in removing trees from</p>	<p>- As the access is considered temporary, the stone will be removed when final work ends so the wetlands can be restored. 1/26-3/15/06.</p> <p>- The damage to the 3<sup>rd</sup> wetland should be repaired. 3/15/06.</p> <p>- The 1<sup>st</sup> crossing could also use some clean stone. Sediment will have to be carefully removed. 1/4-3/15/06.</p> <p>- Retain shrubs and low growth as much as</p>	<p>-N/A until evaluated at the end of work.</p>
